Downstream migration of Atlantic salmon smolts at Unkelmühle power station and Buisdorf dam in 2016

NINA Report

Havn, T.B., Økland, F., Heermann, L., Thorstad, E.B., Teichert, M.A.K., Sæther, S.A., Tambets, M. & Borcharding, J. 2018. Downstream migration of Atlantic salmon smolts at Unkelmühle power station and Buisdorf dam in 2016. NINA Report 1412. Norwegian institute for nature research.

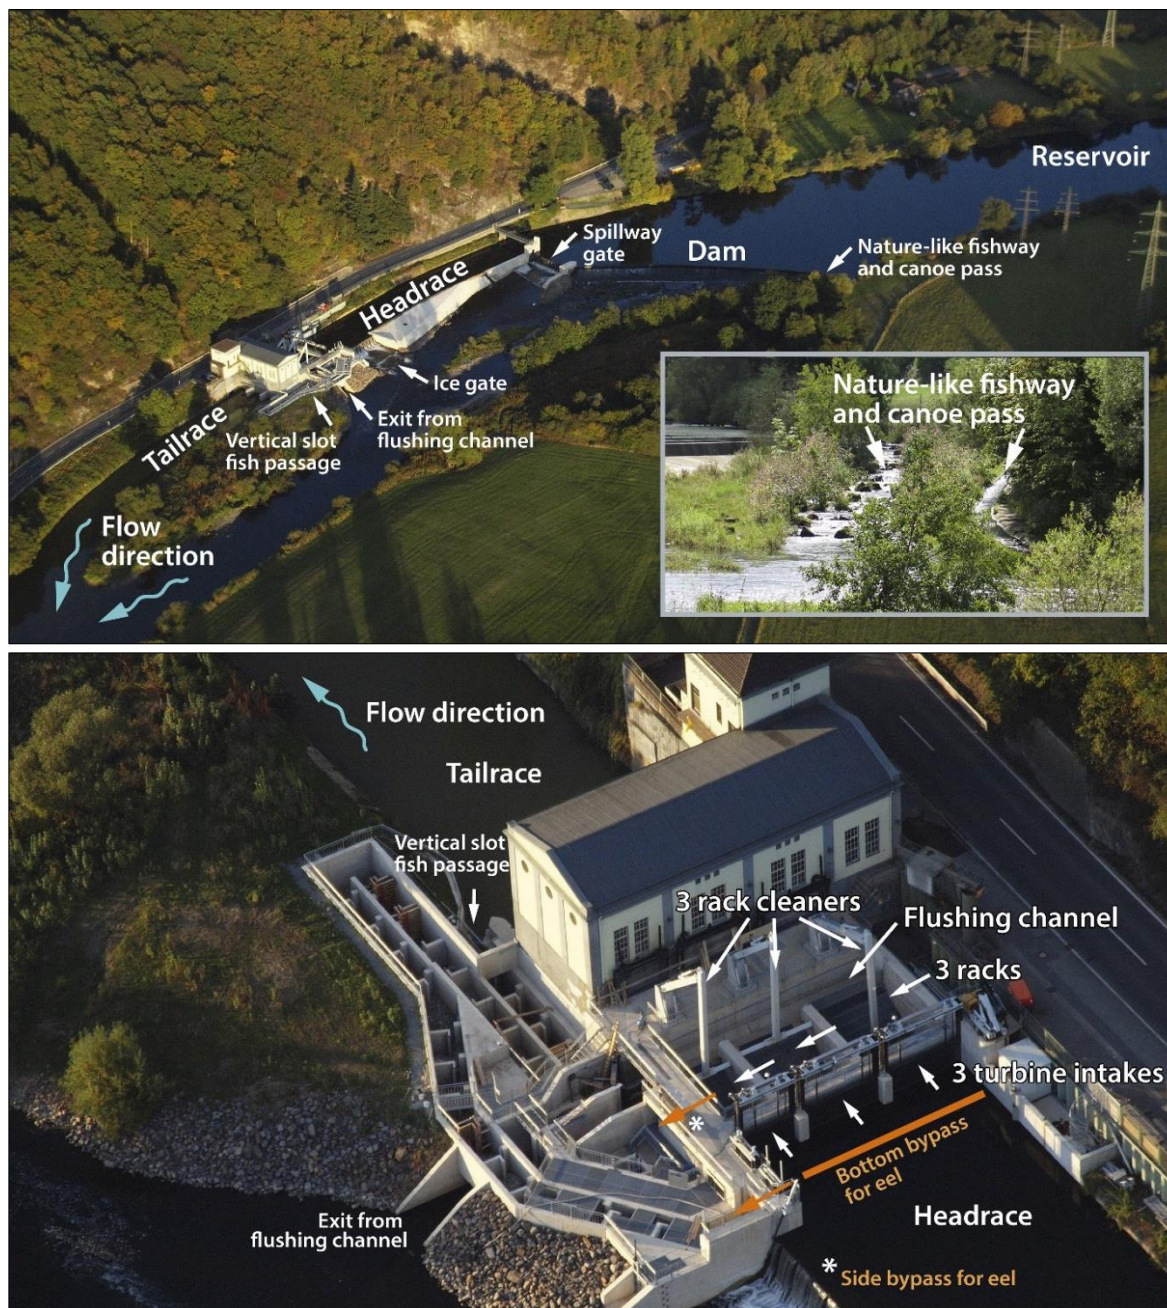
Figure 2.1. Unkelmühle power station with the different passages where downstream migrating fish can pass. The upper panel shows an overview of the power station area, and the lower panel shows the power station in more detail. The different migration routes past the power station are further described in **figure 2.2**. Photos: Wikimedia Commons and Eva B. Thorstad.

Unkelmühle is a run-of-the river power station on the Sieg, 44 km upstream from the confluence with the Rhine (**figure 2.1, 3.1**). The reservoir upstream of the power station is 2.3 km long and narrow (99 m at the widest). The reservoir has no water storage capacity and the water level is kept at 90.069 m.a.s.l., but can be higher during floods.

Ten migration routes can be used by downstream migrating fish past the power station (**figures 2.1-2.3**). Bottom and side passes designed for eel were not in operation during this study. The spillway gate was open for 6.2 days in the beginning of the study period (study

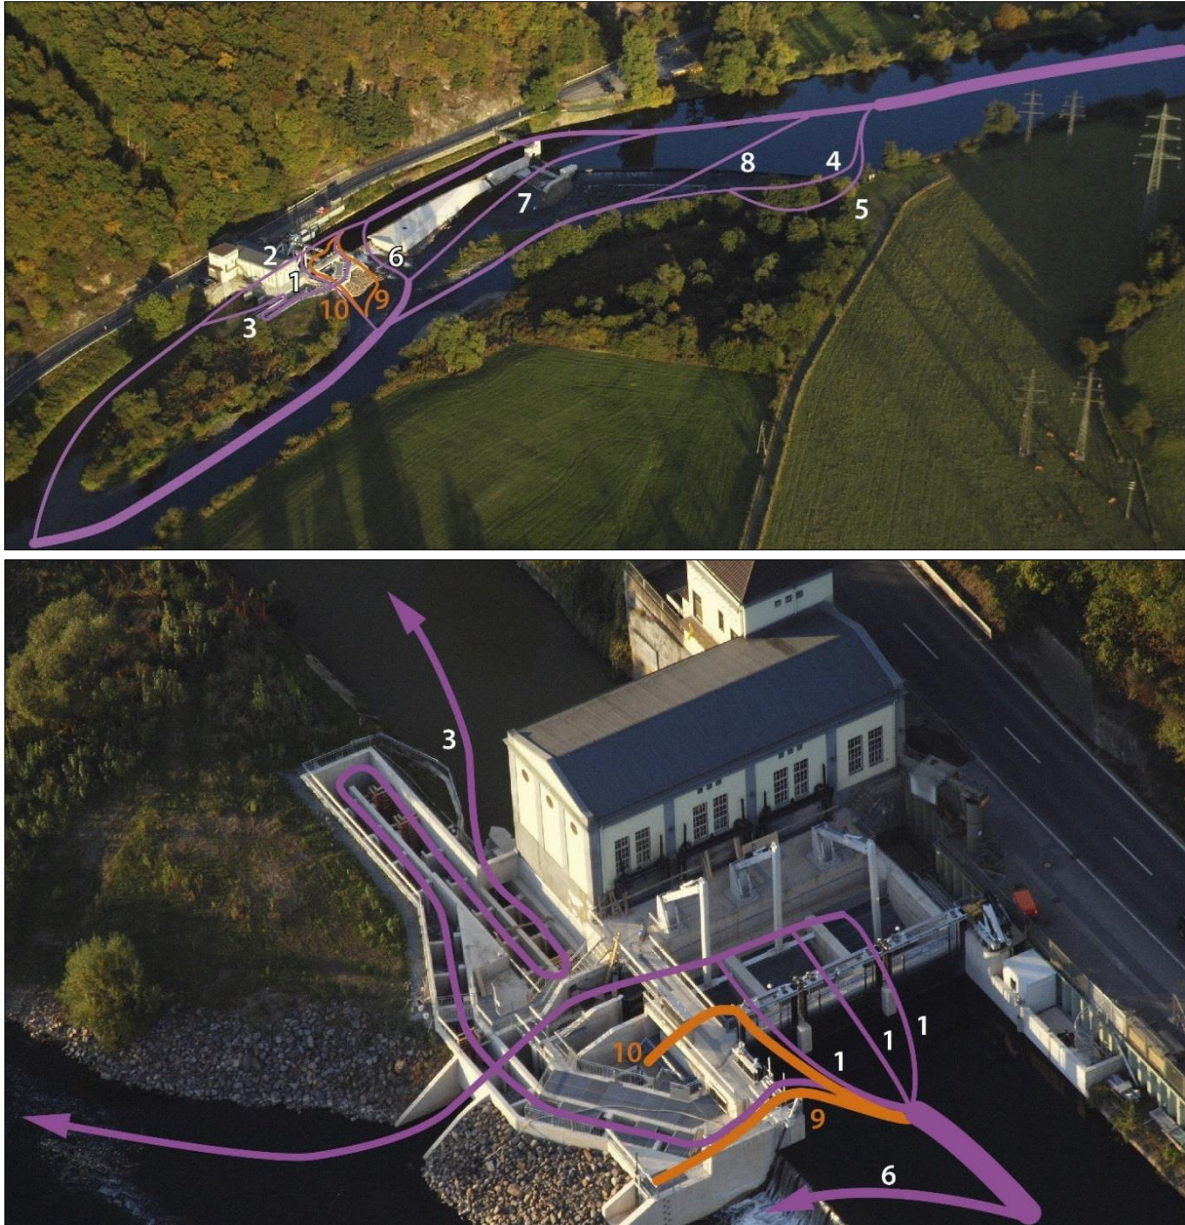
Figure 2.2. The different routes downstream migrating fish can use to pass the Unkelmühle power station: 1) via the surface bypass; custom-made openings in the racks that leads fish to a route outside the turbines via the flushing channel, 2) through turbines if they slip through the bar spacing of the racks, 3) through the vertical slot fishway constructed for upstream migrants, 4) through the nature-like fishway, 5) through the canoe pass, 6) via the ice gate, 7) over the spillway gate, 8) over the dam, 9) via the bottom bypass for eel, and 10) via side bypasses for eel (the two latter, indicated in orange, are only in operation during the eel run in the autumn). Numbers in both panels refer to the different migration routes. Photos: Wikimedia Commons.

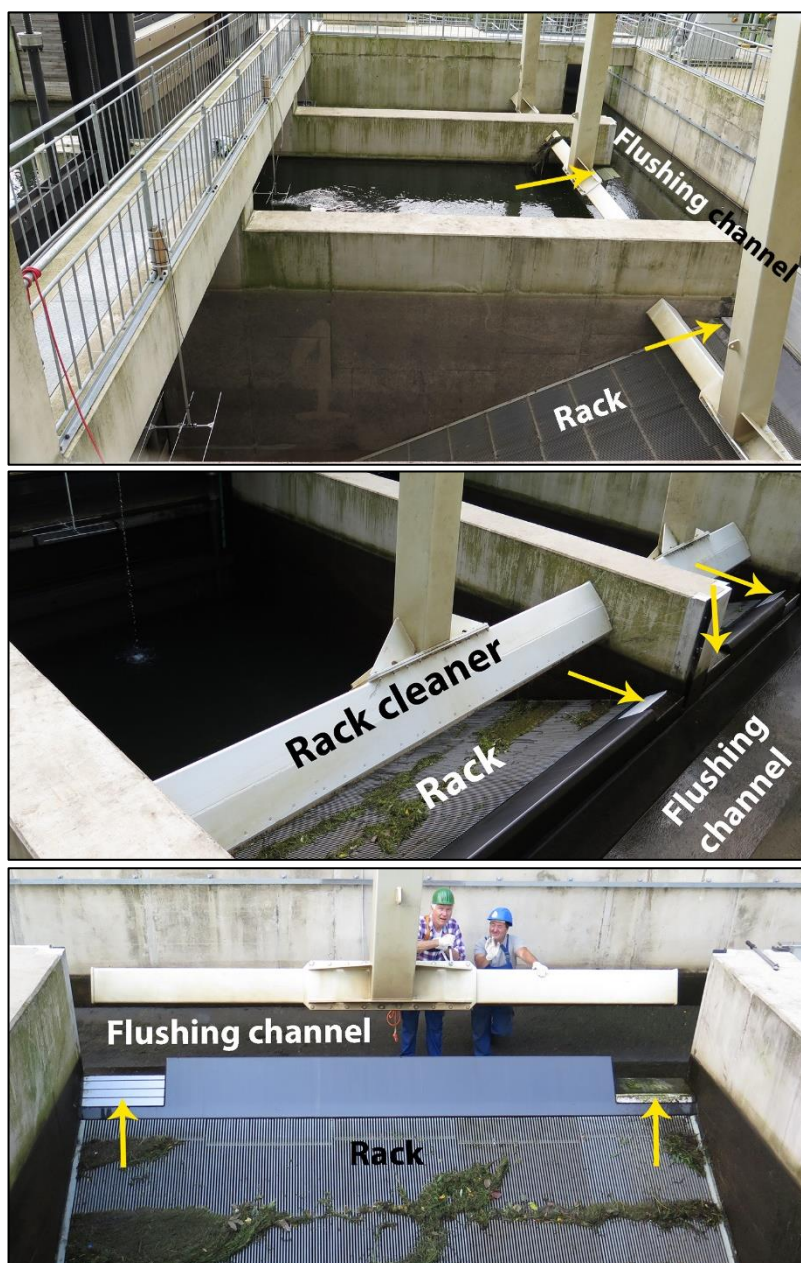
Figure 2.3. Details from the turbine intake at the Unkelmühle power station.

Upper panel: The three turbine intakes with racks and rack cleaners. Yellow arrows show custom-made openings near the surface where fish approaching the rack can pass through and move into the flushing channel. There are two openings in each rack, one on each side, in total six openings. Fish that enter the flushing channel can follow a migration route past the power station outside the turbines (shown in figure 2.2). When turbines were operating during this study, the water level covered the racks, openings and flushing channel. When the photo was taken, only two turbines were operating and one of the racks was therefore not water covered. Yagi antennas detecting signals from tagged fish in each of the turbine intakes can also be seen.

Middle panel: Two of the three turbine intakes.

Lower panel: Two rack openings of different depth, where fish can pass (turbine not operating).

One of the possible migration routes for downstream migrating fish is through custom-made openings in the racks (14 or 24 cm deep and 70 cm wide) in front of the turbines, which enable them to bypass the turbines via the flushing channel (termed surface bypass, water discharge $0.6 \text{ m}^3\text{s}^{-1}$, **figure 2.2, 2.3**). During this study, fish could move freely to and from the flushing channel at all times. From the flushing channel, they were either guided to holding pools where they were collected for monitoring purposes, or they were guided back to the river outside the turbines via a channel. Debris from the racks were flushed out in the same channel when the rack cleaners were in operation. Which of these two routes fish are guided to is determined by the position of a movable valve. The operation of the rack cleaners depends on amount of debris. During periods of high water and increased debris transport, they are continuously operated.

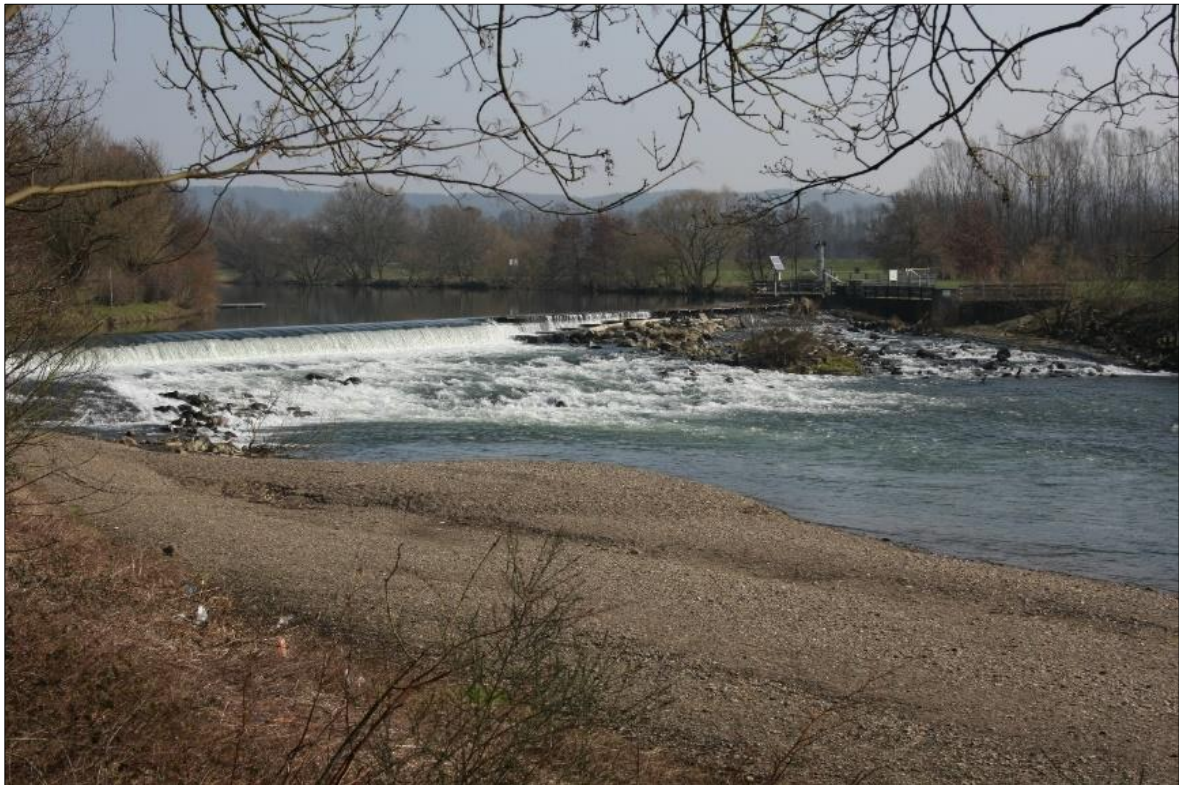
Figure 2.4. Buisdorf dam. Photo: Torgeir B. Havn

Buisdorf dam in the River Sieg is located 29 km downstream of Unkelmühle power station and 15 km upstream of the confluence with the River Rhine. When it was constructed more than 500 years ago, its main purpose was to serve water for the gardens of the monastery Saint Michael. Later, water mills were installed in the dam, which supplied power for industrial purposes. The reservoir upstream the dam (1.9 km long, **figure 2.4, 3.1**) is used as a rowing area for a local rowing club.

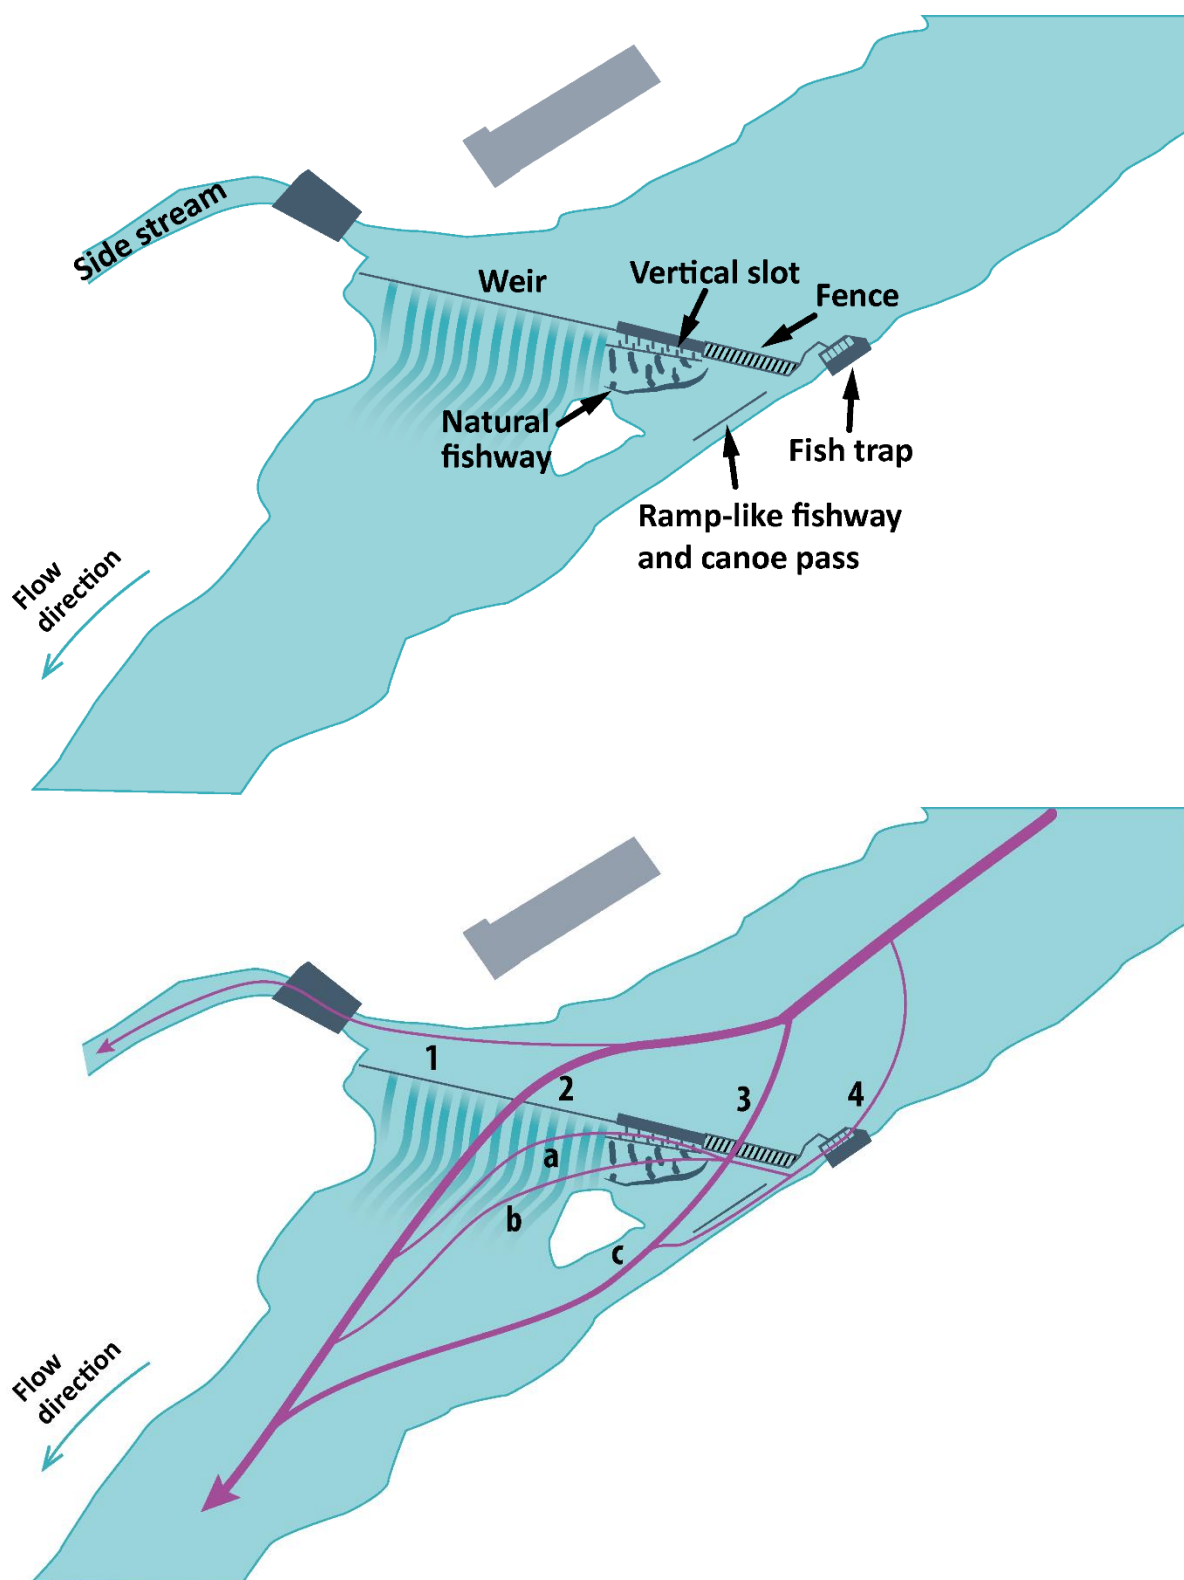
Figure 2.5. The upper panel shows an overview of the dam, and the lower panel shows the different migration routes past the dam. The lower panel shows the routes: 1) via the side stream, 2) over the weir, 3) through the fence or 4) through the fish trap, and then via a) the vertical slot fishway, b) natural fishway, or c) ramp-like fishway or canoe pass.

Downstream migrating fish can choose between eight different migration routes past the dam (**figure 2.5**). Fish can pass the dam over the weir, or via a side stream (water discharge $0.5 \text{ m}^3\text{s}^{-1}$ during flooding, otherwise it depends on the discharge in the Sieg) and thereafter re-enter the river 5.1 km below the dam (**figure 2.5**). In 1999, a monitoring station was constructed at the south bank of the dam, enabling counting (the station is periodically equipped with a VAKI fish counter) and catching of upstream migrating fish. Downstream migrating fish can also pass the dam through the monitoring station, and fish using this route or fish passing the dam via a fence (bar spacing adjustable 40-60 mm) can thereafter migrate through a vertical slot fishway (7 pools, maximum water current at 1.9 ms^{-1}), a nature-like fishway (length: 65 m, width: 15 m, water current: 0.5 to 2.0 ms^{-1}) or via a ramp-like fishway or canoe pass (**figure 2.5**). The head of the dam is 2.6 m.

Of the 37 smolts that passed the dam, 35 smolts (95%) migrated over the weir (route 2) while two (5%) passed through the fence and then moved down the ramp-like fishway or canoe pass (route 3-c, **figure 4.3**, see **figure 2.5** for route numbers).

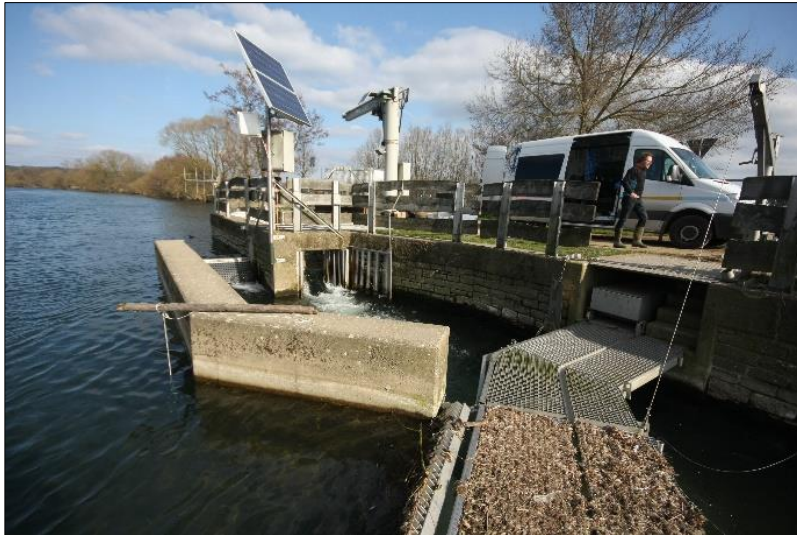
Figure 2.6. Details from the Buisdorf dam.

Upper panel: The fish trap at the dam. Upstream migrating fish move through the entrance and are trapped in a 10 m² chamber. A 900 l tank, capable of holding up to 50 adult Atlantic salmon, is lifted from the floor of the trap to collect the fish.

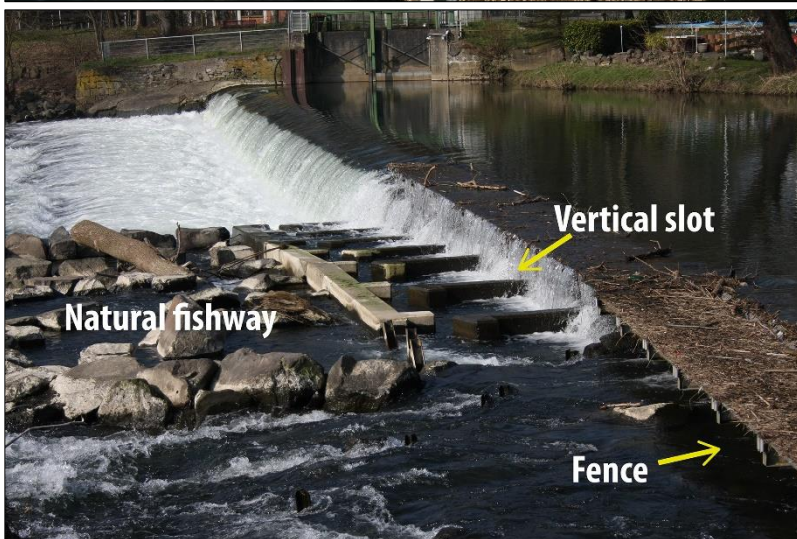
Middle panel: Fish passing the dam through the fish trap or fence can migrate further downstream via the vertical slot fishway, natural fishway or ramp-like fishway or canoe pass. The weir can be seen in the background.

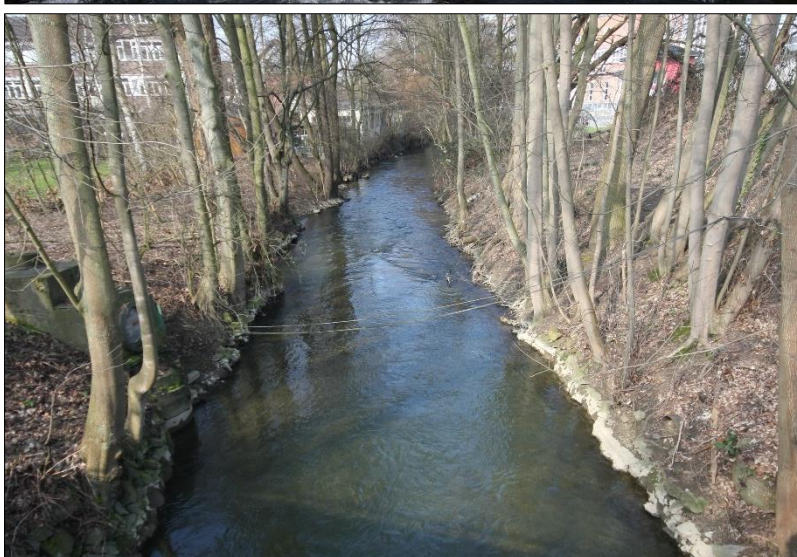
Lower panel: The side stream which re-enters the main river 5.1 km downstream of the dam.

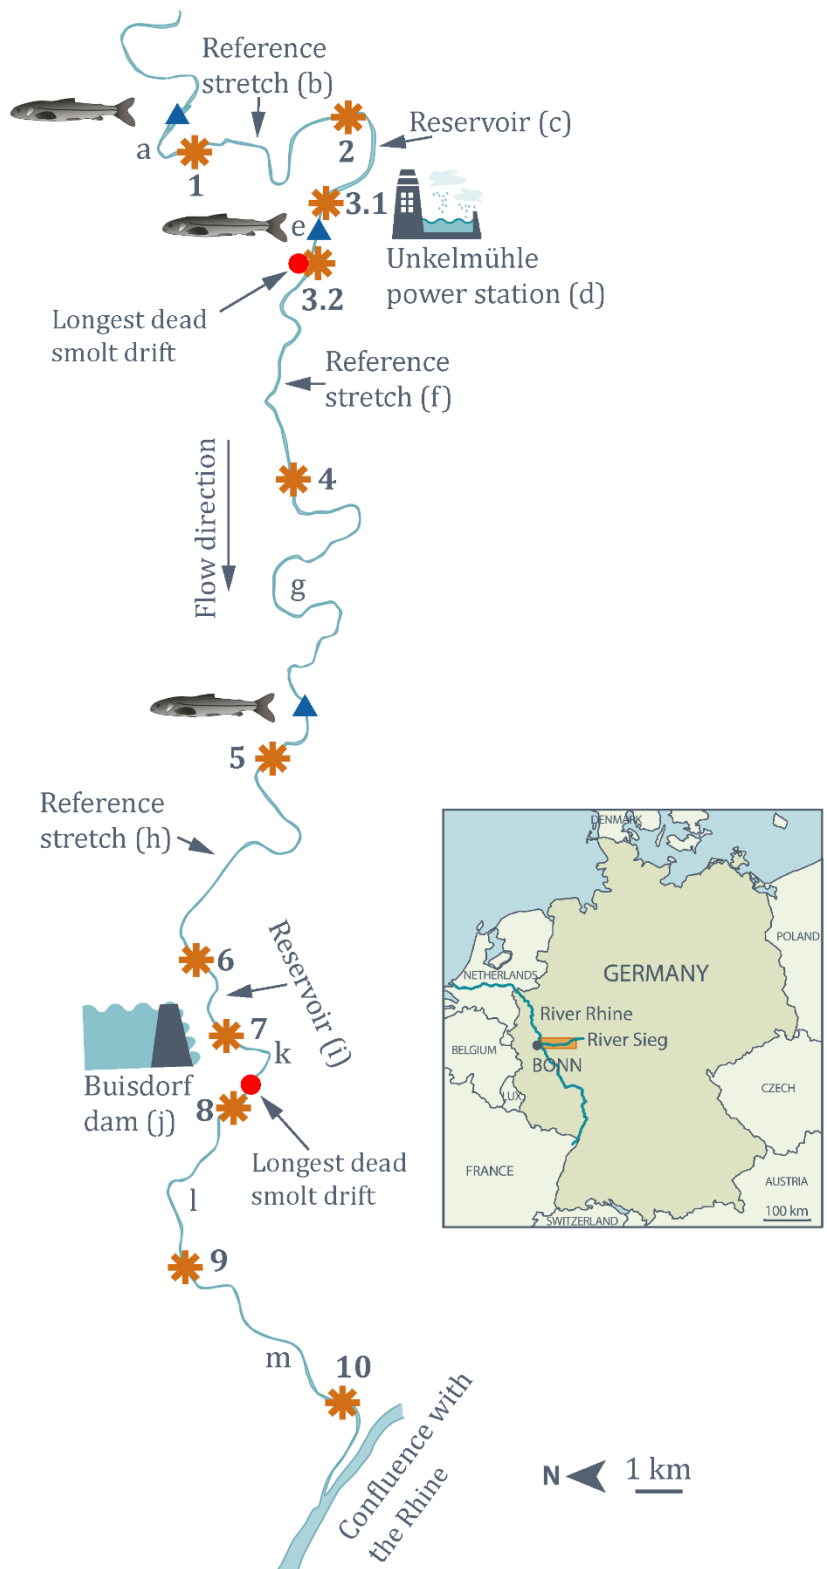
Figure 3.1. Map of the River Sieg showing the three different release sites of smolts tagged with radio transmitters (blue triangles) and receiver sites (orange stars) where they were recorded. The different stretches are denoted with letters a-m. Lengths of the stretches are given in **table 3.2**. The longest drift of already dead smolts released at Unkelmühle power station and Buisdorf dam are shown.

Table 3.1. Capture and release information for radio tagged smolts in the Sieg 2016. Letters denoting stretches refer to **figure 3.1**. Water discharge and temperature were measured at Unkelmühle power station.

Table 3.2. Description of the different river stretches at Unkelmühle and Buisdorf, their lengths and distances from the most upstream release site. Stretches are denoted with letters referring to **figure 3.1**.

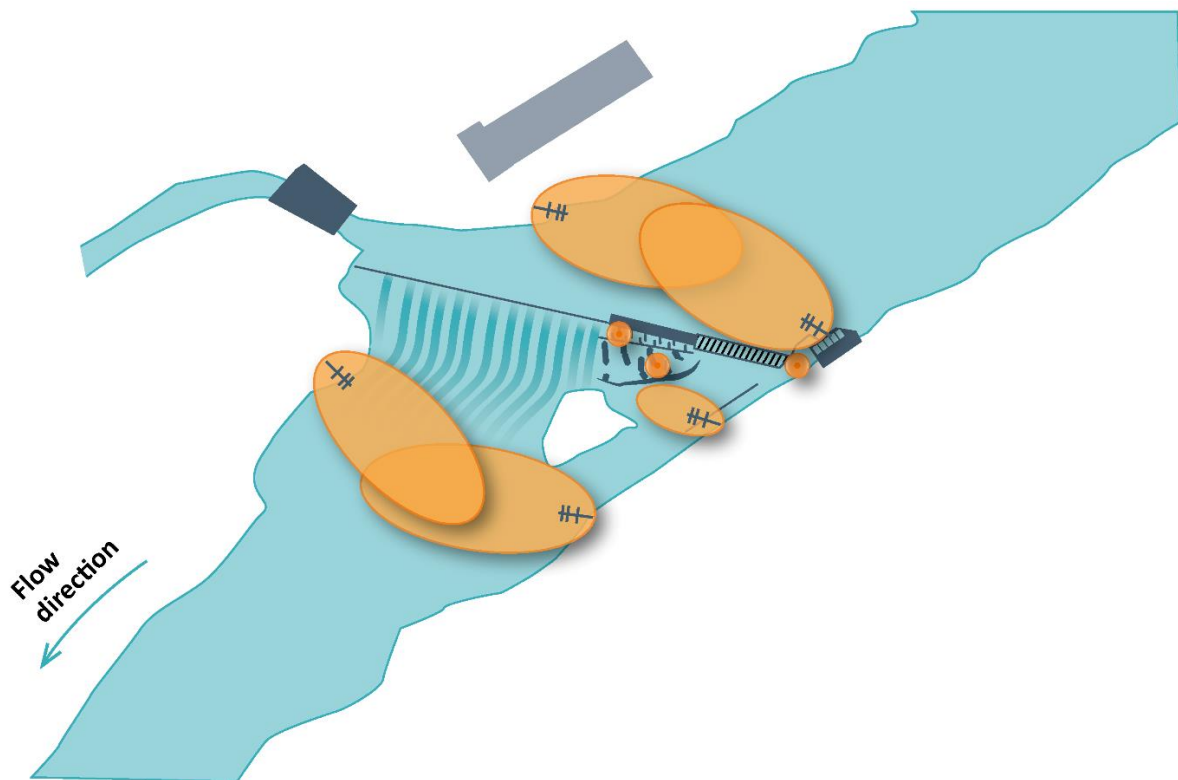
Figure 3.2. Overview of radio antennas and their approximate detection ranges (in orange) used to record signals from radio tagged smolts at Buisdorf dam. Detection ranges with antenna symbols indicate the use of aerial Yagi antennas, whereas ranges without antenna symbols indicate the use of underwater coaxial antennas.

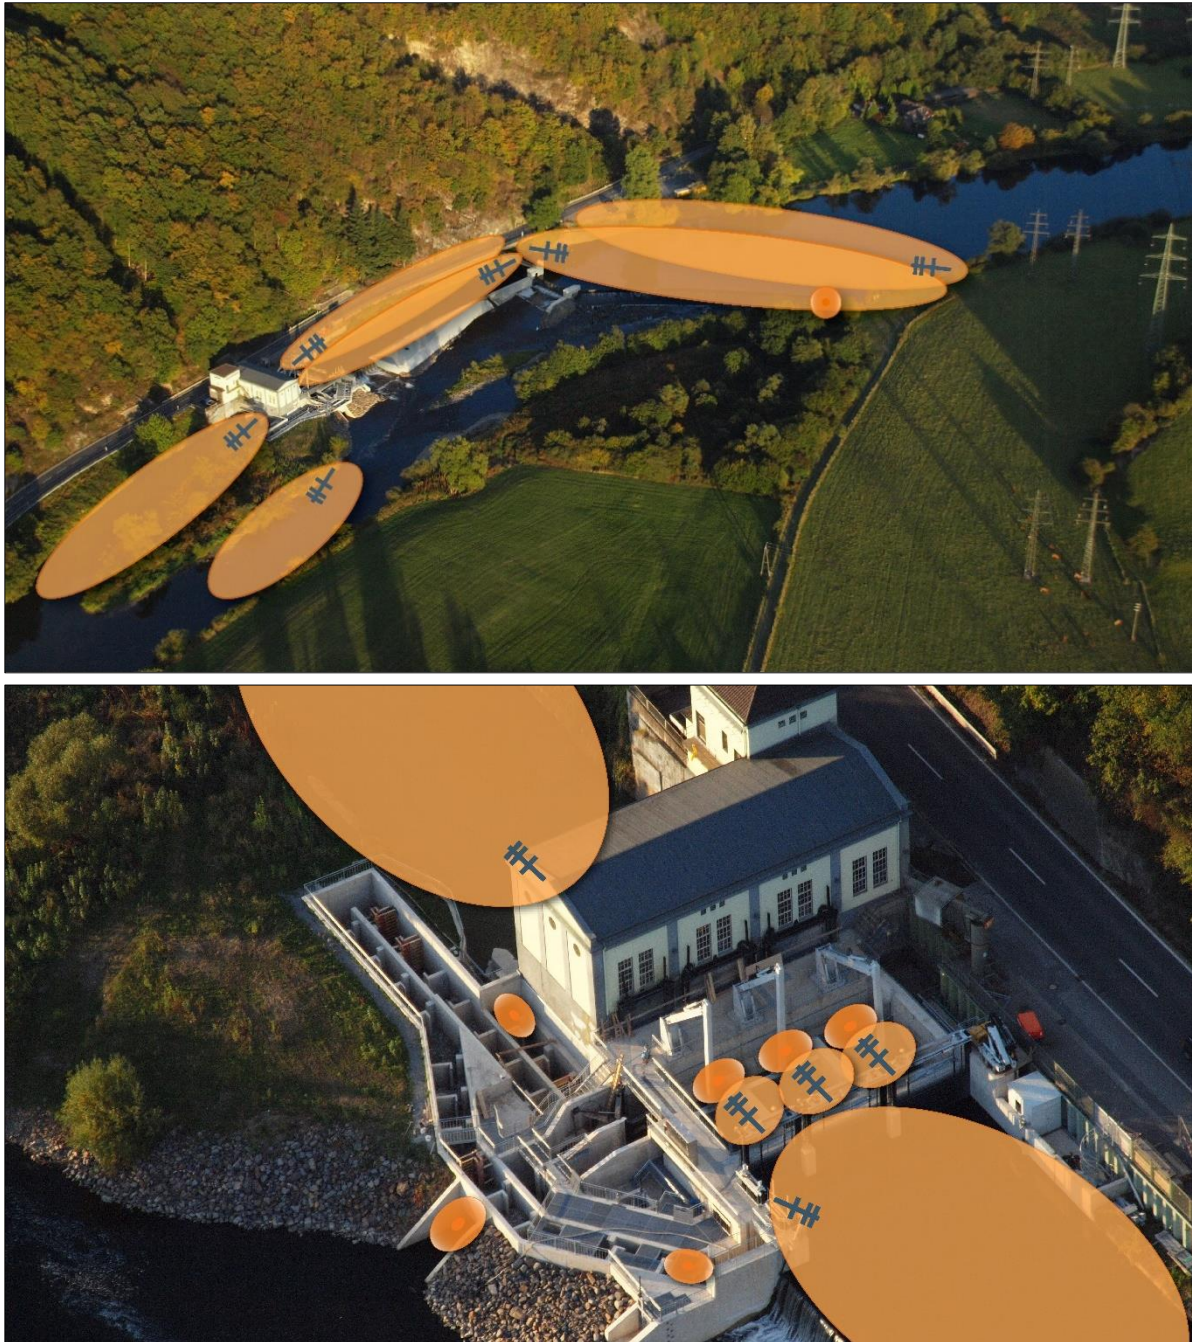
Figure 3.3. Overview of radio antennas and their approximate detection ranges used to record signals from radio tagged smolts at Unkelmühle power station. **Upper panel:** Overview of the power station area. **Lower panel:** Power station area in more detail. Detection ranges with antenna symbols indicate the use of aerial Yagi antennas, whereas ranges without antenna symbols indicate the use of underwater coaxial antennas Photos: Wikimedia Commons.

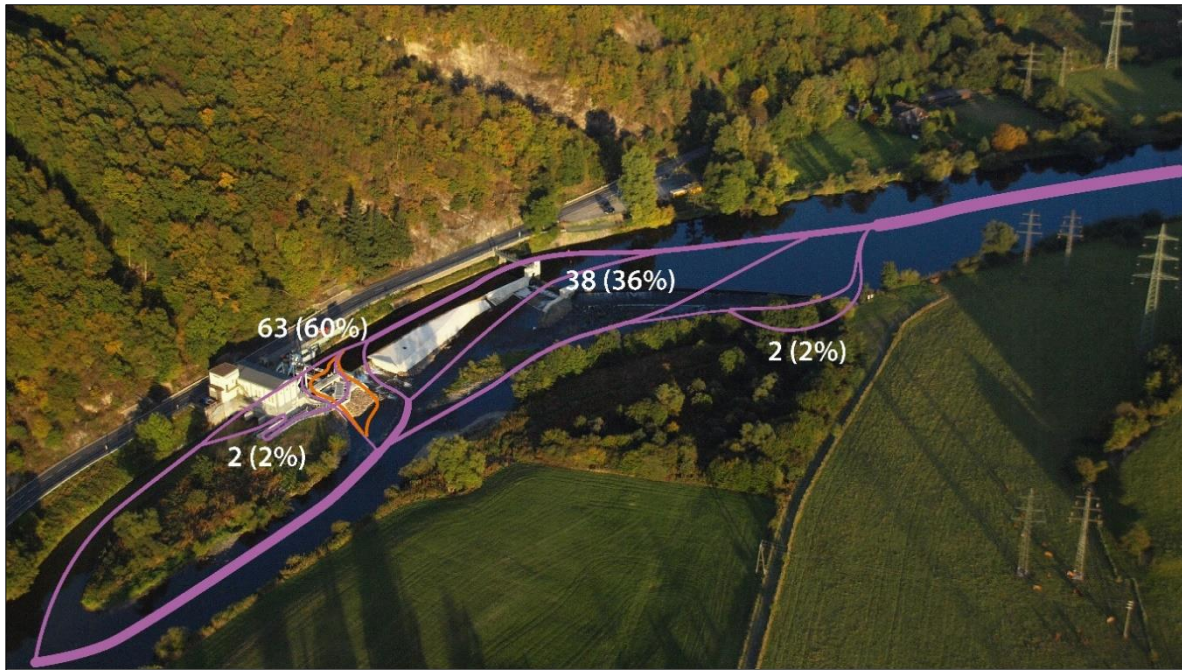
Figure 4.1. Number and proportion of smolts using the different migration routes past the power station

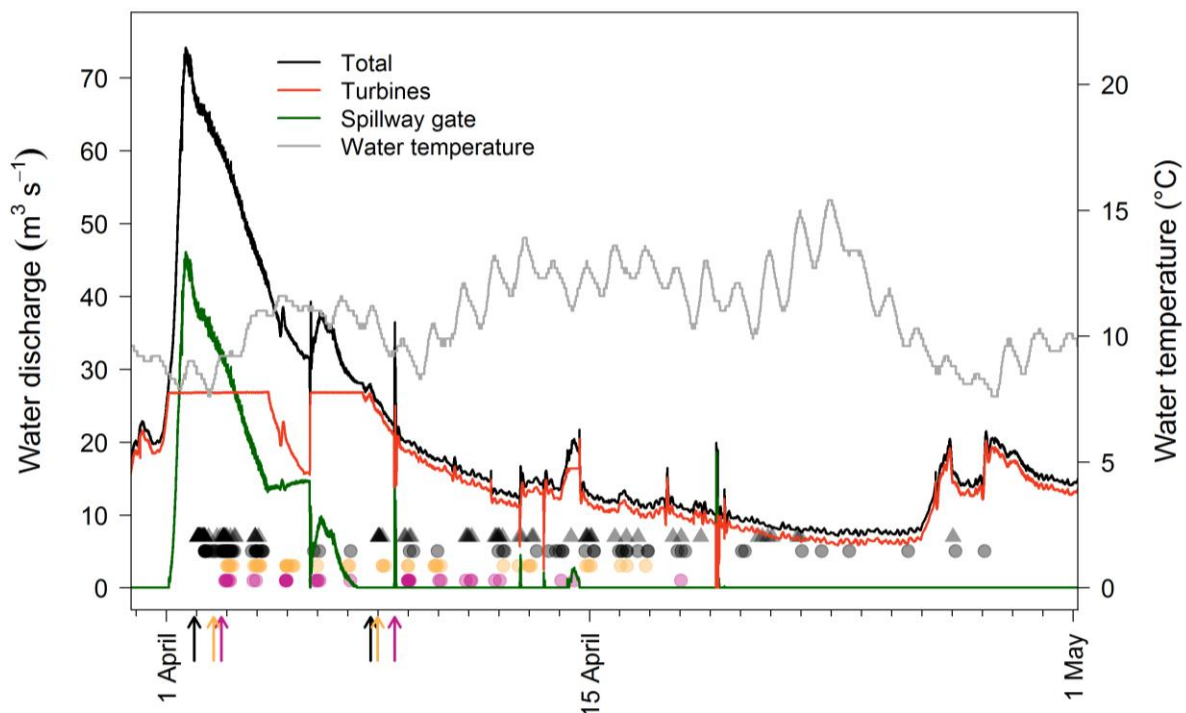
Figure 4.2. Total water discharge (black line), turbine discharge (red line), spillway gate discharge (green line) and water temperature (grey line) recorded at Unkelmühle power station during the study period. Time of release of tagged smolts is shown for the groups (see **table 3.1**) released upstream of Unkelmühle power station (black arrows, Unkelmühle 1 and 2), just downstream of the power station (orange arrows, Downstream Unkelmühle 1 and 2) and at Buisdorf (pink arrows, Buisdorf 1 and 2). Black triangles indicate when individual smolts passed Unkelmühle power station and colored circles when they passed Buisdorf dam (different colours represent different release groups, corresponding to the arrow colours). The symbols are transparent, so the darker colour, the more fish have passed at that point in time.

A total of 227 smolts were radio tagged and released, of which 120 were released upstream of Unkelmühle power station, 60 just downstream of the power station and 47 upstream of Buisdorf dam (**figure 3.1, table 3.1**). In addition, 20 already dead smolts were tagged and released immediately downstream of the power station and the dam to distinguish between live downstream migrating fish and dead drifting fish (**table 3.1**). All smolts were captured for tagging by guiding them from the flushing channel to holding pools during their downstream migration at the power station, except for 5 smolts taken from the Agger hatchery (**table 3.1**). Groups of smolts were released at different points in time to increase variation in environmental variables during their downstream migration (**table 3.1**). Neither body length or body mass differed between live smolts released upstream of Unkelmühle (mean length: 159 mm, mean body mass: 34.8 g), downstream of Unkelmühle (mean length: 158 mm, mean body mass: 35.9 g) or at Buisdorf (mean length: 156 mm, mean body mass: 33.2 g, One-Way ANOVA of body length: $F_{2,224} = 0.33$, $P = 0.72$, One-Way ANOVA of mass: $F_{2,224} = 0.69$, $P = 0.50$). Water discharge and water temperature at release are shown in **table 3.1** and **figure 4.2**.

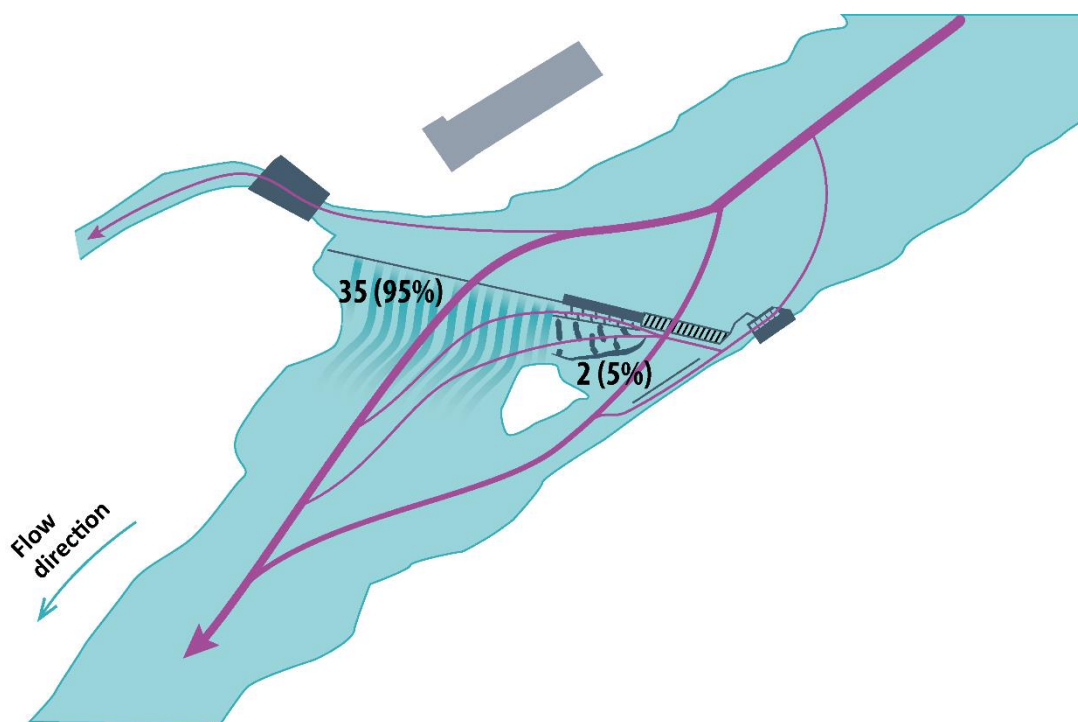
Figure 4.3. Number and proportion of smolts using the different migration routes past the dam at Buisdorf.

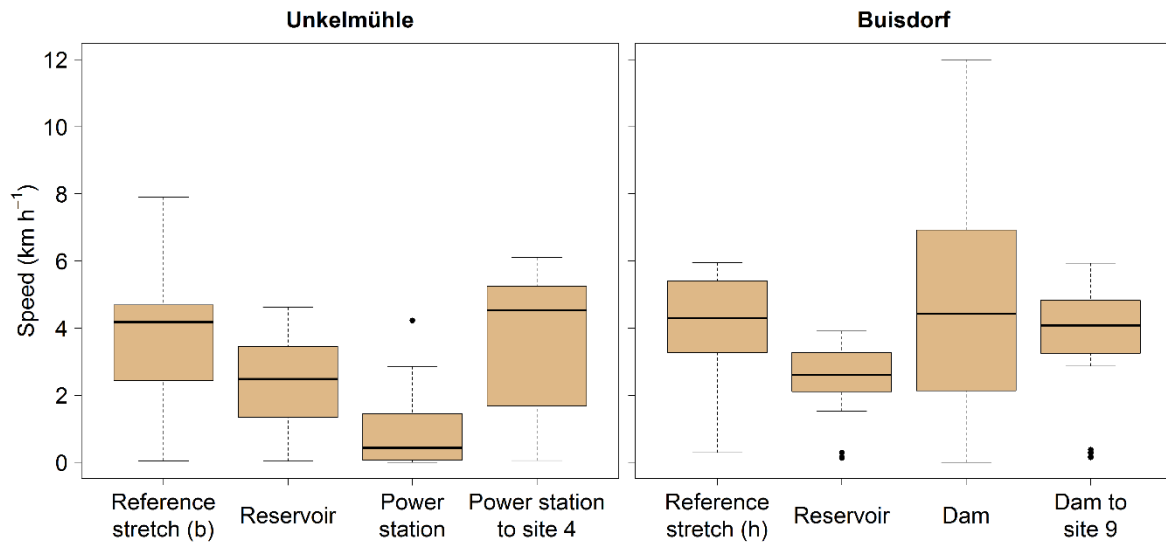
Figure 4.4. Migration speed past the reference stretch, reservoir, power station and downstream stretch for fish released upstream of Unkelmühle (left panel, groups Unkelmühle 1 and 2, $n = 93$) and migration speed past the reference stretch, reservoir, dam at Buisdorf and downstream stretch for fish released at Buisdorf (right panel, groups Buisdorf 1 and 2, $n = 34$). Boxes show the median (middle line within the box) and upper and lower quartile of data (*i.e.*, 50% of the data values are within the box). Whiskers show the range of data (within the upper / lower quartile ± 1.5 IQ) and dots show outlier values.
